Torsey Pond Watershed Survey

June 2017

Prepared by: Cobbossee Watershed District, with
Torsey Pond Association

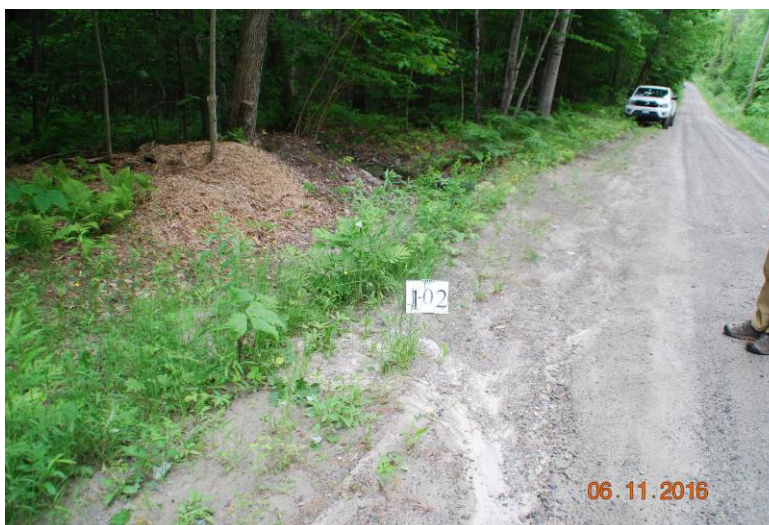
NPS Site #102 (Medium Priority) – Road Surface, Ditch, and Shoulder Erosion

NPS Site #102 - This site is on Beans Mills Road approximately 750 feet from the junction with Rte. 41. This section of road is characterized by moderate erosion to the road surface, shoulder, and adjacent ditch. As a result of the shoulder erosion and the existence of shoulder berms along the road edge, runoff is unable to leave the road and shoulder and enter the ditch. The runoff, in fact, continues past an existing culvert causing further erosion.

This photo is looking down Beans Mills Road to where a culvert passes beneath the road. Because the road lacks a proper crown and there are berms built up that prevent runoff from shedding off the road surface into the ditch and then the culvert causing surface erosion.

Recommendation for NPS Site #102 – Ideally, the road shoulder should be graded to remove all vegetation and any accumulated gravel and sediment and the adjacent ditch should be improved. The road surface should be crowned to better shed water to adjacent wooded areas.

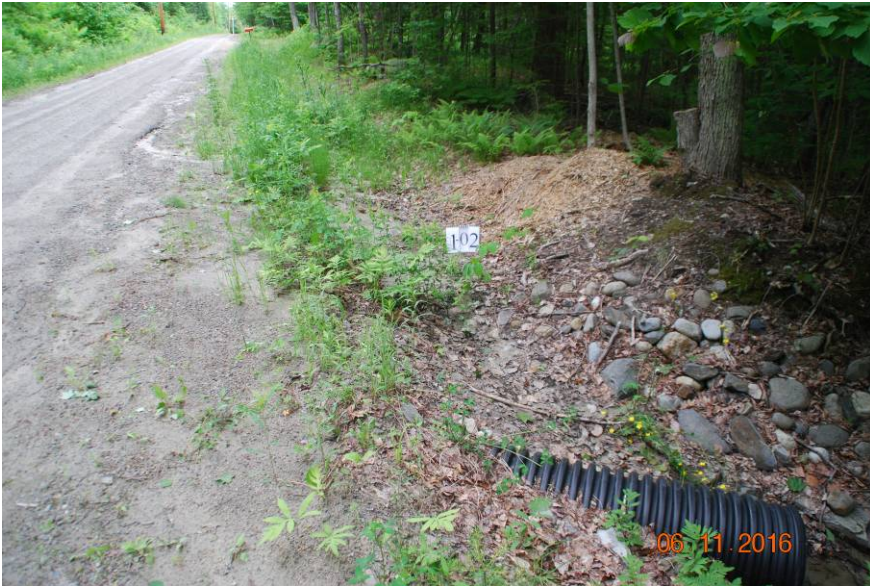
This is a reverse angle of the photo above showing signs of erosion and surface flow past the undefined ditch and bypassing the culvert and causing further erosion of the road surface and shoulder.

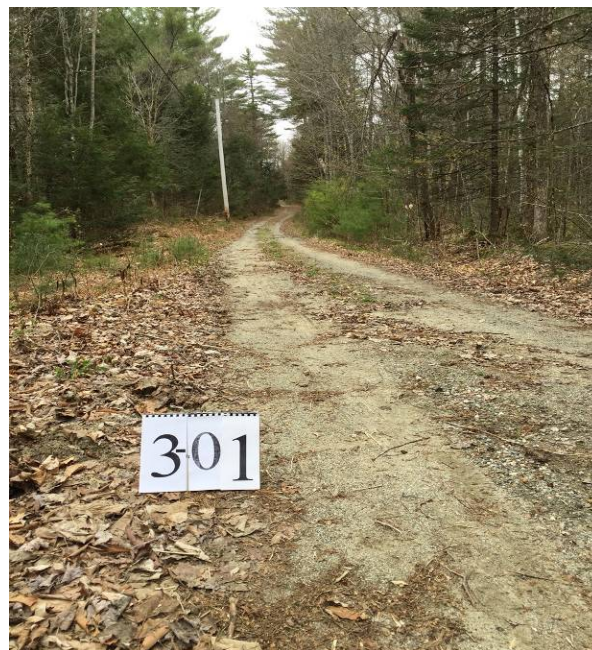
NPS Site #310 (High Priority) – Road Surface Erosion/Grader Berms

NPS Site #301 – This site is located at a low point in Five Seasons Road where it crosses a small tributary stream to Torsey Pond. This is a High Priority site in that runoff from the road causes surface erosion and direct deposit of eroded material into a perennial tributary to the pond.

This is a view up the road from the base of the road near a tributary stream to the pond. As can be seen, runoff coming down the road has no opportunity to shed to adjacent wooded areas thereby causing surface erosion and transport of sediment to the tributary below.

Recommendation for NPS Site #301 – The road surface should be crowned, shoulder berms removed, and a ditch installed along both sides of the road with periodic turnouts to the adjacent wooded buffers. At a point where the road closely approaches the stream crossing, there should be runoff diversions (e.g., waterbars) installed to deflect runoff to the newly installed ditches.

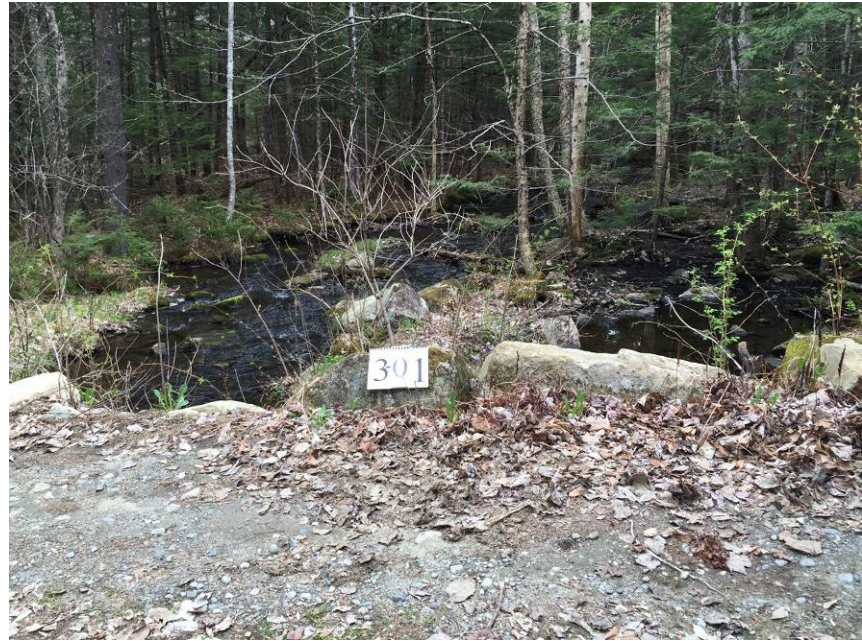
Here, runoff from the road surface shown in photo above enters the tributary which flows directly into Torsey Pond downstream.

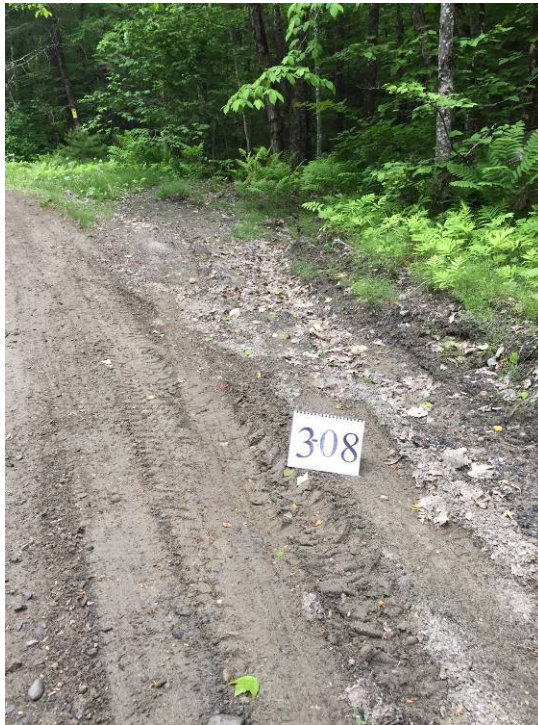
NPS Site #308 (High Priority) – Road Surface and Ditch Erosion with Grader Berms

NPS Site #308 –This site is located along Desert Pond Road – a town road – in the Town of Mt. Vernon on the opposite side of the road from the pond. The road surface here is severely disturbed and the shoulder severely eroded. This site flows directly into a tributary stream (outlet stream from Desert Pond) and then beneath the road and discharges sediment-laden water to Torsey Pond. There are also signs of severe ditch erosion and grader berms along the road shoulder that prevents runoff from shedding to the ditch or to adjacent wooded areas.

This is a view looking along Desert Pond Road with clear evidence of severe road shoulder erosion and discharge of eroded material into a modestly wooded area with stream channel not in view.

Recommendation for NPS Site #308 – The grader berms should be removed and the fill slope between the shoulder and the roadside vegetated ditch should be graded, seeded, and with periodic turnouts to enable filtered road runoff to enter the ditch and/or adjacent wooded areas.

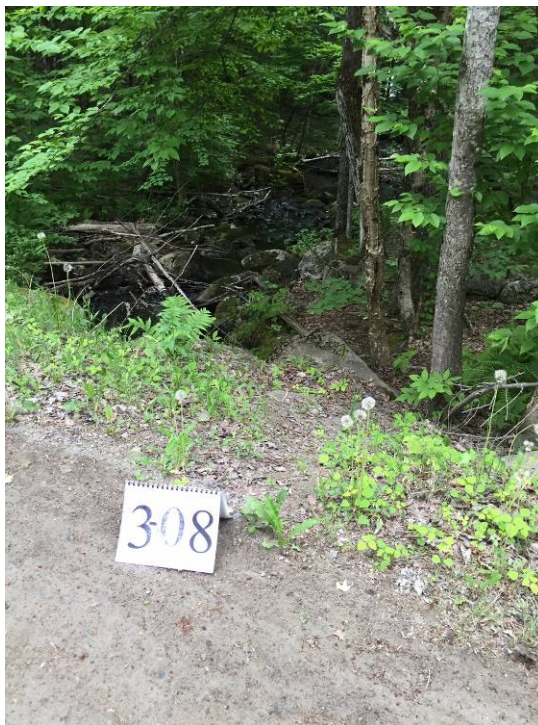
This is a photo showing where the eroded road and shoulder material enters a tributary stream to Torsey Pond

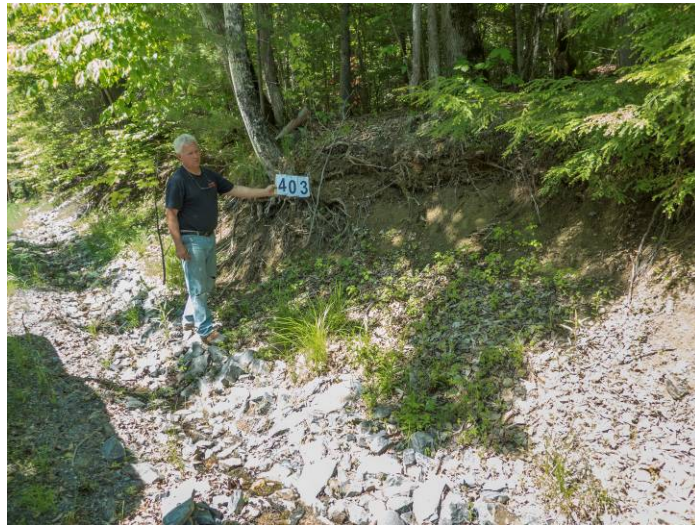
NPS Site #403 (High Priority) – Ditch Erosion/Unstable Culvert In/Out

NPS Site 403 – This site, located on Desert Pond Road in Mt. Vernon represents a series of NPS problems. There is severe bank failure and ditch erosion along a significant portion of the road although there is evidence of efforts to make repairs. Beneath the road is a large corrugated metal culvert with very severe erosion along the outfall channel which flows to the pond.

This is a photo showing a portion of the eroded road bank and shoulder along Desert Pond Road.

Recommendation for NPS Site #403 – The road banks and ditches in this section of Desert Pond Road need to be more strongly armored with rip-rip and the road surface needs to be improved (crowned). The inlet of the large corrugated metal culvert beneath the road should be armored with rip-rip and the outlet channel needs extensive armoring with rip-rip or large rock.

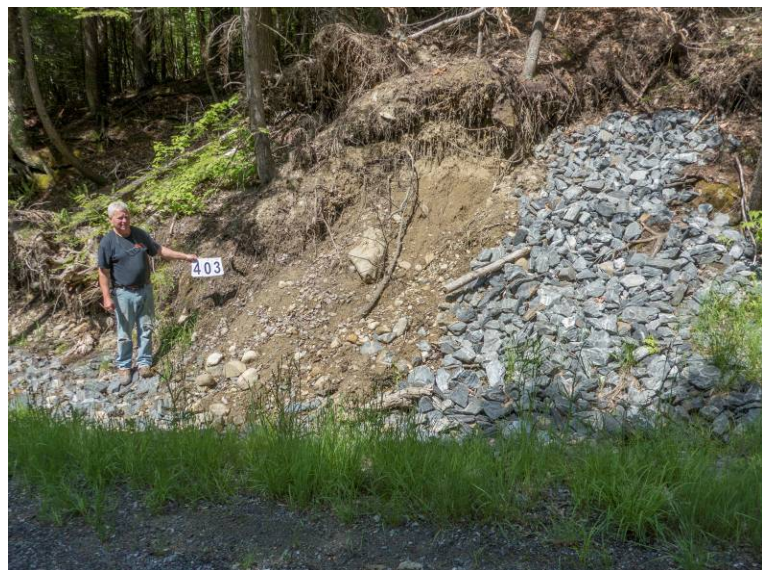
This is a photo showing another section of the eroded road bank and shoulder along Desert Pond Road.

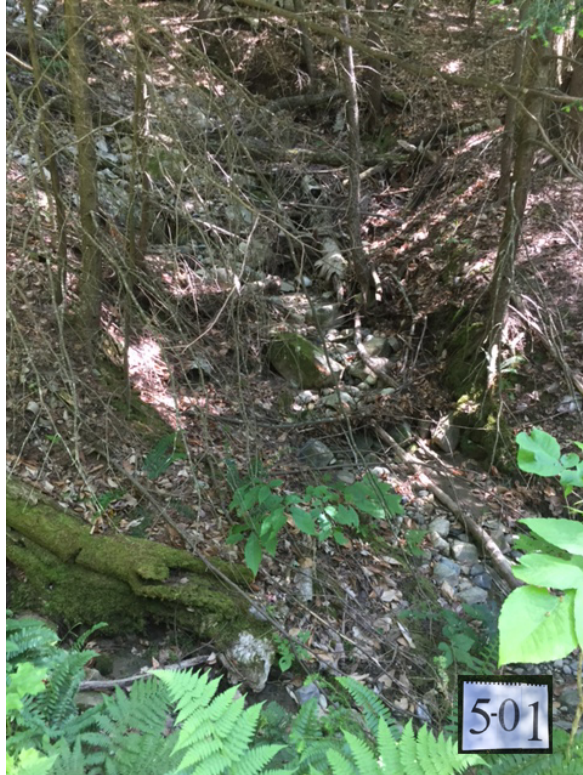
NPS Sites #501 through 503 (High Priority) – Gulley Erosion

NPS Site #501 - #503 – These sites are located in the vicinity of Audrey and Roland Lanes along the northeast portion of the pond. The problems associated with sites 510 and 502, in particular, originate up-gradient of the roads. These sites represent severe gulley erosion with some obvious and direct evidence of sediment entering the pond.

This photo of Site #501 shows severe gulley erosion.

Recommendation – These three sites represent some of the more severe erosion detected in this survey. They will all require engineered solutions before any construction/stabilization should take place. A likely approach will include re-grading the gulleys and stabilizing with a combination of geotextiles and heavy rip-rap and large rock armor.

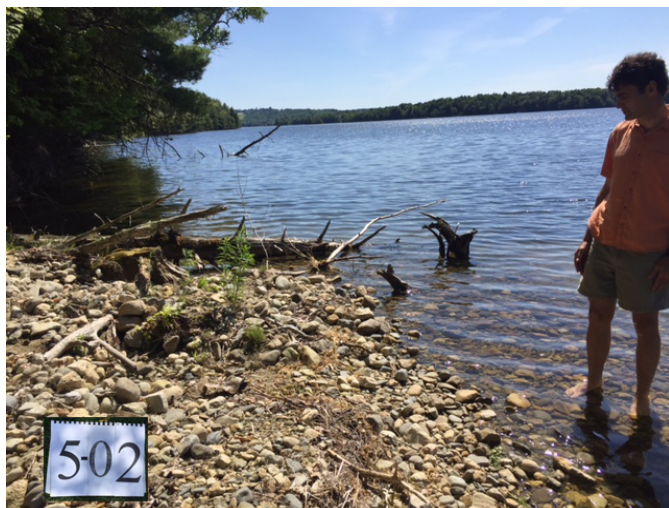
This photo shows a significant sediment and rock deposit from site #502 in the nearshore zone of the pond.

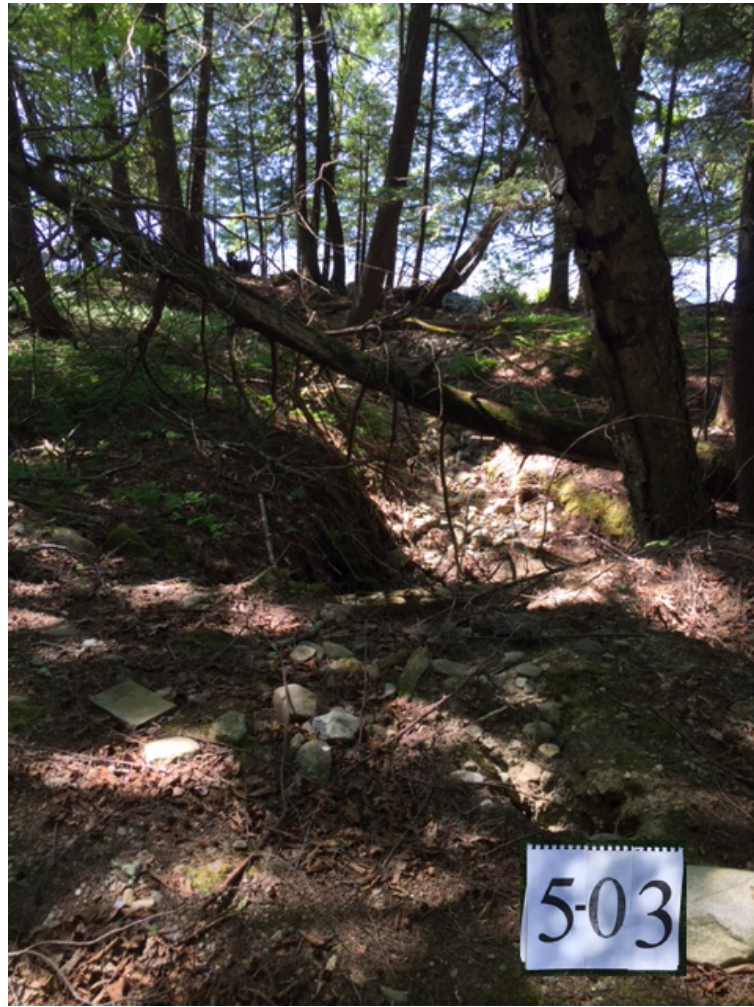
This photo shows significant gully erosion at site #503 with Torsey Pond in background.
